HOWARD NEEDLES TAMMEN AND BERGENOFF NEW YORK  
CHESAPEAKE CITY BRIDGE. BRIDGE INSPECTION REPORT NUMBER 118.(U)  
DEC 79

REPORT DOCUMENTATION PAGE		READ INSTRUCTIONS BEFORE COMPLETING FORM
1. REPORT NUMBER	2. GOVT ACCESSION NO.	3. RECIPIENT'S CATALOG NUMBER
4. TITLE (and Subtitle) Bridge inspection report no 11B, Chesapeake City Bridge, Maryland		5. TYPE OF REPORT & PERIOD COVERED Bridge Inspection report no. 11B, Contract report 1979

The findings and recommendations for the 1979 inspection of the Chesapeake City Bridge (Route designation, U.S. Route 213) which crosses the Chesapeake and Delaware Canal was undertaken for the Department of the Army, U. S. Corps of Engineers by Howard Needles Tammen & Bergendoff (HNTB) and are submitted herein. A location map is presented in Drawing 1-0.

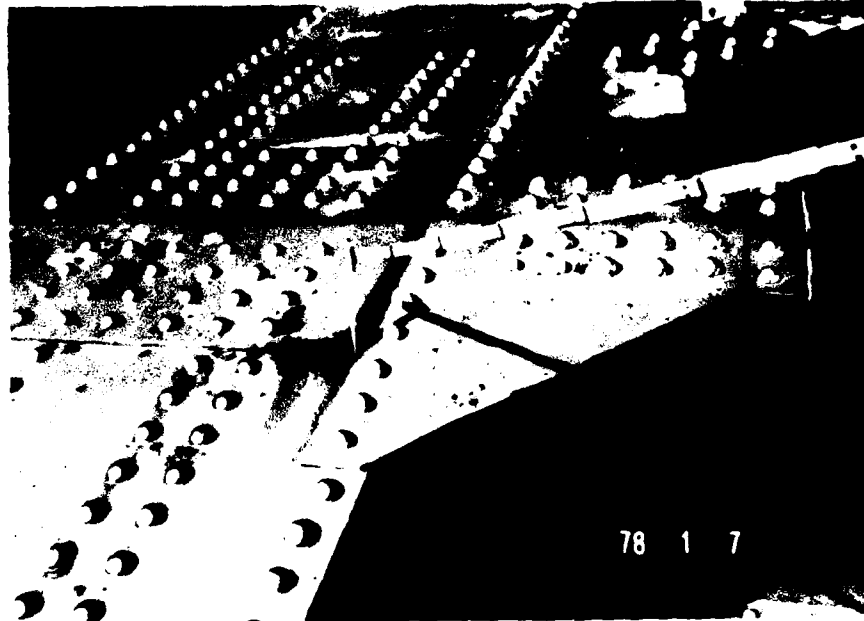
Rust has caused a 1/2 inch separation between the edges of upper splice plate and upper cover plate at Panel Points U2 and U3 of

Photograph 15 - Separation of corner of upper splice plate and upper cover plate on the top chord of the west tied arch due to rust.

the east and west arches. (See Photograph 15.) These gaps should be cleaned and sealed.

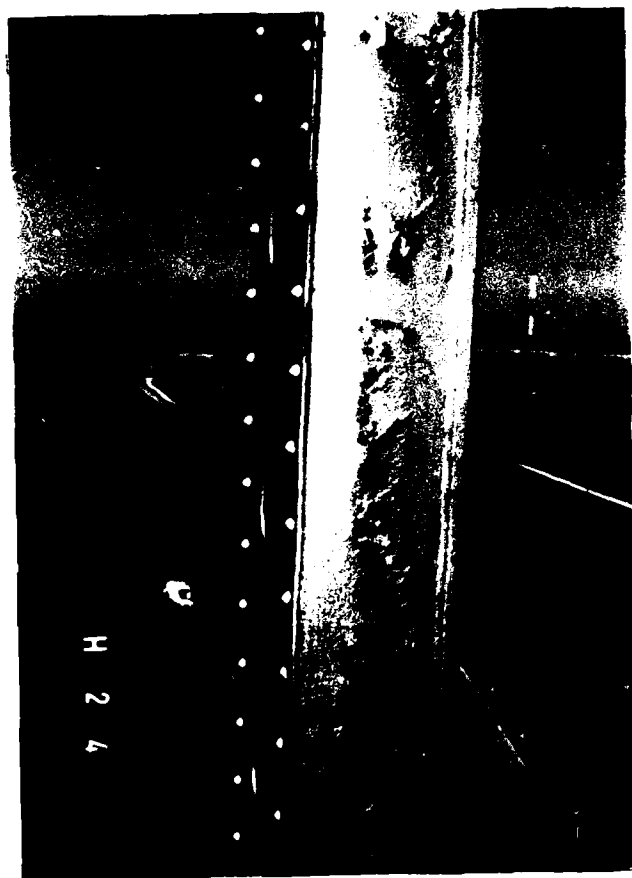
There are isolated areas of blistering of paint and minor section loss on the superstructure of the arch span located above the roadway, including the interior of the hangers and upper chord. The heaviest blistering is on the roadway side of the hangers. (See Photograph 16.)

Photograph 16 - Typical blistering of paint and corrosion on the roadway face of the tied arch hangers.

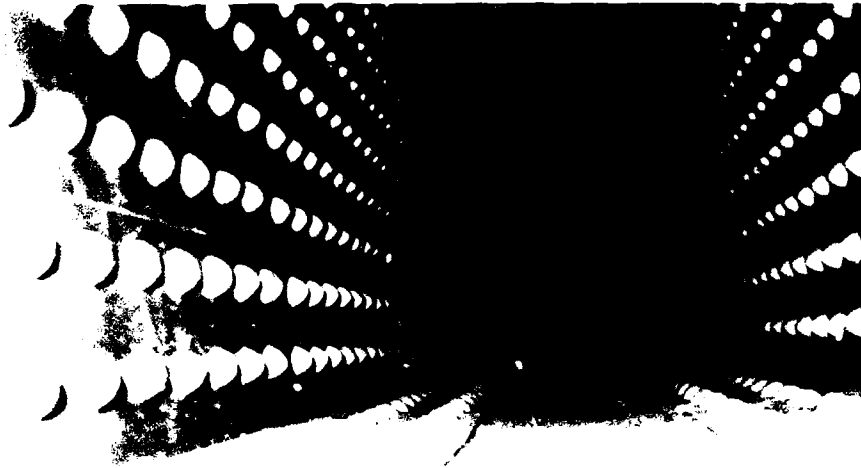
Pigeon roosts were noted in the upper chords of the arch span. (See Photograph 18.) There is a heavy accumulation of bird excrement in these members. We suggest screening the openings in the upper chords to prevent access to birds, as was done to the openings in the tie girders, after the bird excrement has been removed and any subsequent paint damage repaired.

Photograph 18 - Pigeon roost in upper chord of tied arch.

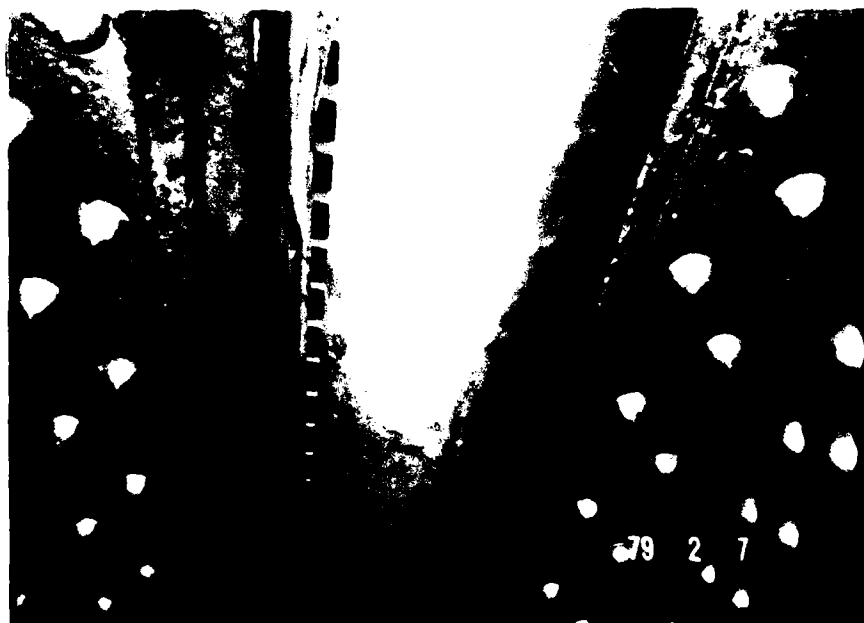
Photograph 21 - Gap between drainage trough and copper baffle that allows water to fall on structural steel and pier top below trough. Tooth dam can be seen through this gap.
